► Report on:

Fire Performance

Volume 1, Number 1

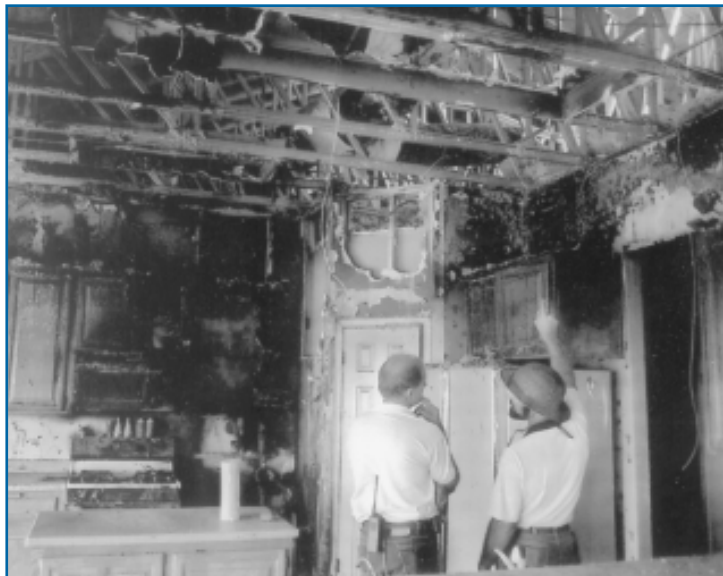
Photo 1: Courtesy of USS Posco

On July 2, 1996, a gas stove caused a fire in the kitchen of a steel framed home in Sommerset at Brentwood, CA. The home, built by Innovative Steel Systems, is one in a 2000 home development.

The fire caused \$75,000 in damages to the interior and personal property. In this steel framed home, the flames were contained to the kitchen with smoke damage elsewhere and no structural failure of the steel roof trusses or wall frames occurred. If this home was of typical combustible construction there would have been additional costs incurred to replace charred members and to chemically treat those charred members that were not replaced to seal in smoky odours.

According to firefighters the fire reached temperatures of 650 to 760°C (1200 - 1400°F) and yet no structural failure of the steel frame occurred. The firemen commented that if the structure was of traditional wood frame, the damages would have been more extensive.

An analysis was performed on the steel truss cord and wall studs in the area most affected by the fire. Physical testing showed that

the mechanical properties of the members still met the specifications for structural steel studs. The zinc coating on the steel remained intact and in some places there was evidence of alloying with the steel substrate to produce galvalume, a product commonly used in manufacturing automotive body panels. As a result of this analysis, none of the framing members needed to be replaced.

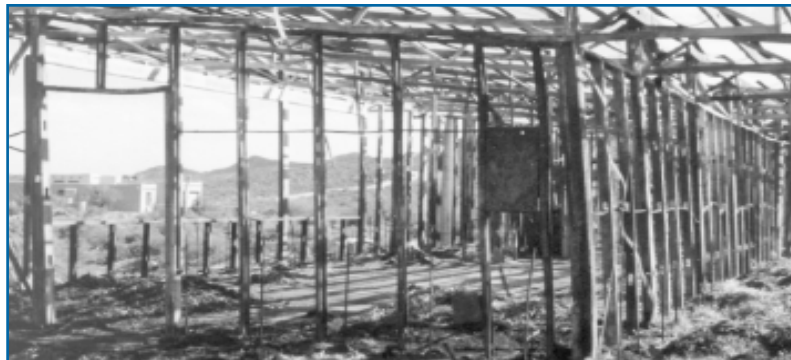
Since this building was not yet finished the fire spread quickly. When Tucson fire response teams arrived, the structure was fully engulfed and a decision was made to let the fire burn itself out. The fire reached temperatures of 650°C (1200°F) which was hot enough to severely crack the concrete floor slab. When the smoke cleared the steel framing was still standing. Doug Emans, assistant fire chief at the scene was surprised. He said "a similar wood structure would have collapsed". Another firefighter commented that wood would have been "toast". In fact 2" x 6" lumber used to frame around some of the openings was just that. With the framing still standing it greatly reduced the fireman's task of checking the debris to ensure all hot embers were out.

The insurance claims adjuster was also impressed. In all of his experiences of inspecting the aftermath of fires he couldn't believe the roof trusses and walls were still standing after all the sheathing had burned off.

Photo 2: "Steel framing still standing after the fire."
